Good work done in the year 2021-22

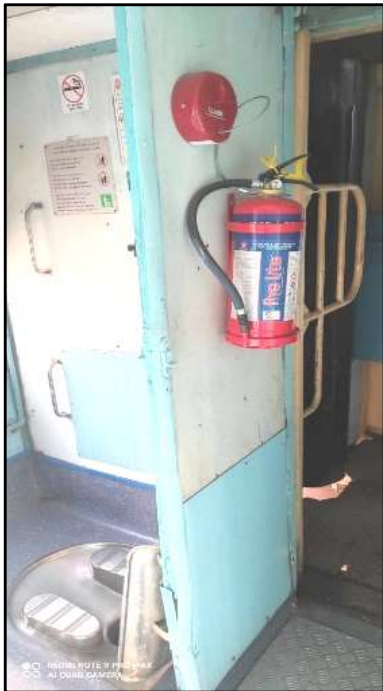
Before

At present fire extinguisher in Non-AC ICF coaches are mounted on wall in vestibule passage outside the lavatory. Protruded fitment of fire extinguishers in passage not only makes passage narrow but also causing difficulty to the passengers.

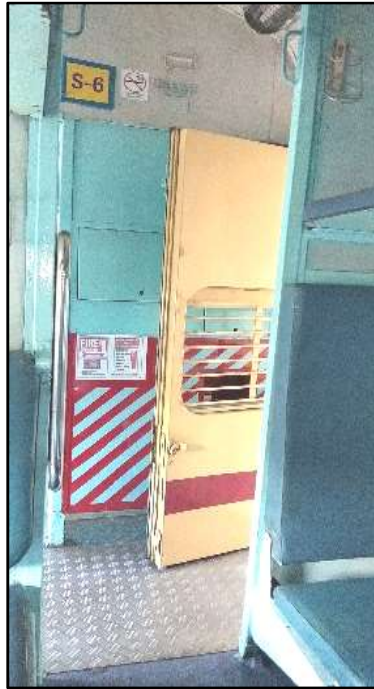
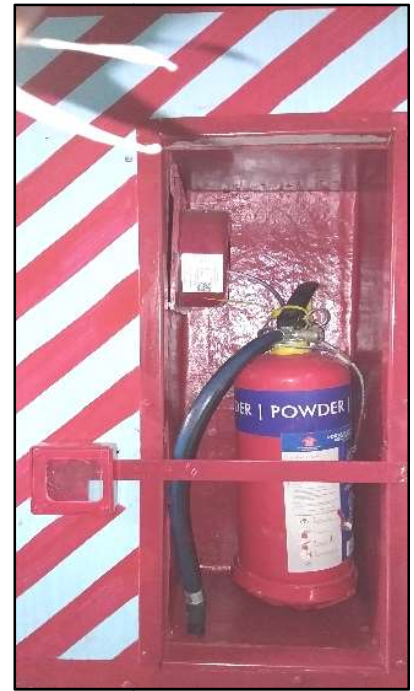
After

To avoid above situation, sunken housing has been developed behind main door in coach no. CR 111146 WGSCN of train no. 02131/32 Dadar - Dadar Sainagar Shirdi Express which is not only accessible easily but also avoids hindrance on passage.

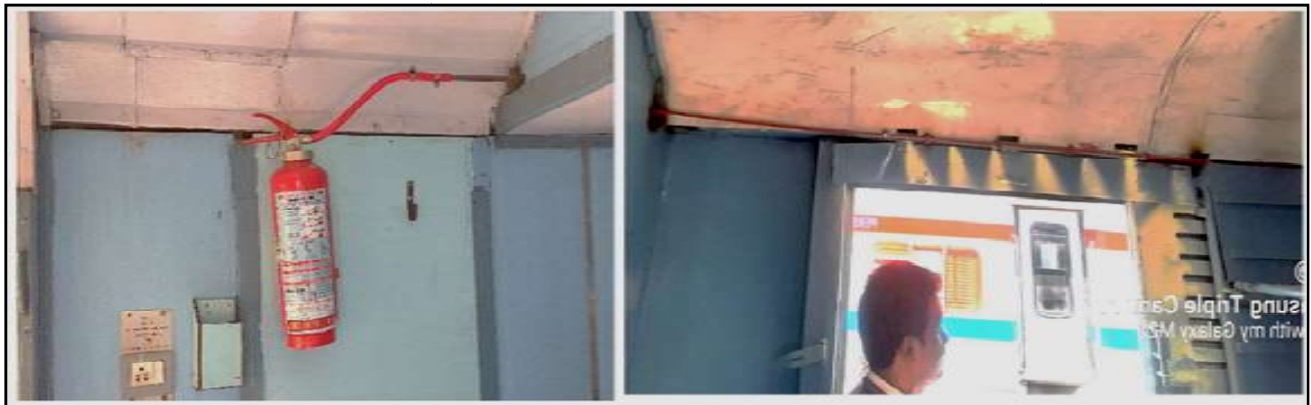
DCP Fire extinguisher mounted on wall inside Guard compartment and connected to pipeline going inside the luggage compartment

Pipeline connected to DCP fire extinguisher has many discharge holes inside the luggage compartment.

In this system, a fire extinguisher is mounted on wall in side Guard compartment is connected to a pipe line having discharge many vent inside the luggage compartment. In case of emergency, fire can be suppressed by removing lock pin of fire extinguisher and simply pressing the operating handle.

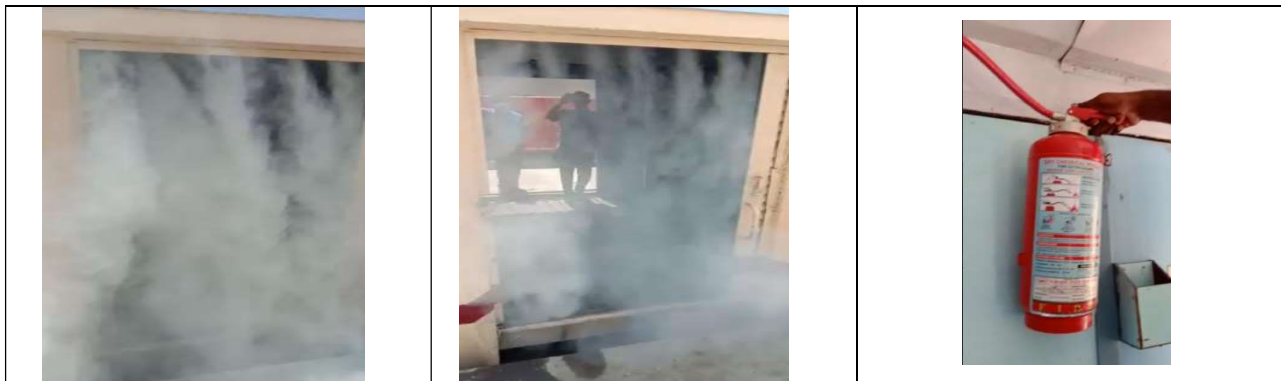
Remote operation of fire extinguisher cause spray of DCP in side luggage compartment

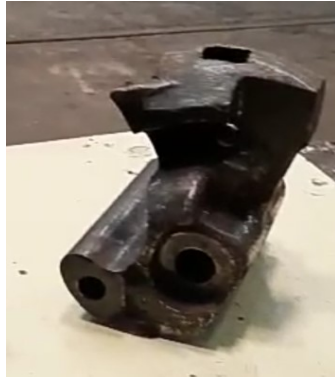
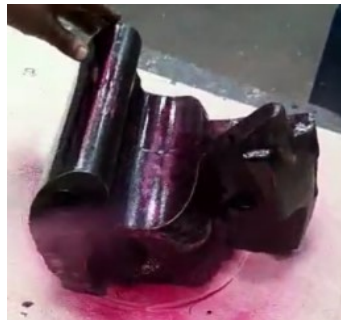
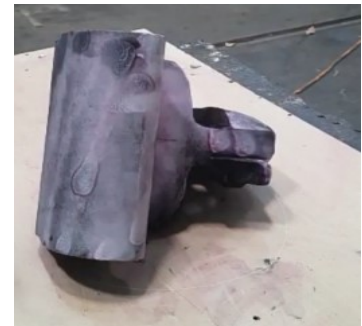
Surface Preparation: The surface is thoroughly cleaned, to make it free from dirt, oil, paint, grease, water, or other contaminants.

Penetrant Application: After a thorough cleaning, Penetrant is applied.

Application of Developer: After a thorough cleaning, a thin layer of developer is applied. And thereafter inspection is done and refitted if passed.

Therefore, as a preventive measure Dye Penetrate Test (DPT) of Knuckle of coaches of 01205 /06 Vidarbha Express was done.

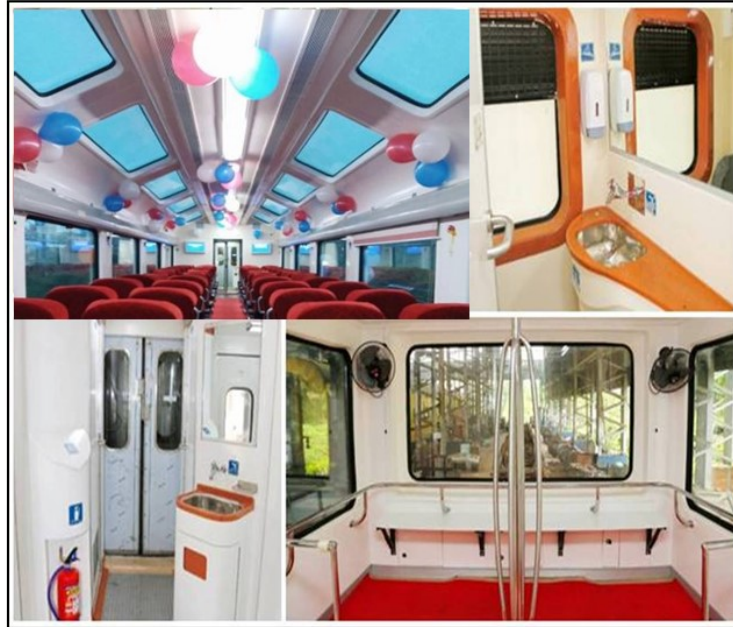
State of the art newly built three (3) Vistadome tourist coaches with larger viewing area including roof top glasses and many other eye catching features have been commissioned on trains no. 11007/08 Deccan Express ,12051/52 Janshtabdi Express and 12123/24 Deccan Queen Express.

- Rotatable seats which can rotate up to 180 degrees for passengers.
- Wi-Fi-based passenger information system.
- Wider entrance doors for divyangjan persons, or those on wheelchairs.
- Automatic sliding doors at the compartment's entry
- CCTV system for onboard surveillance.
- Pressurized flushing systems and bio toilets
- Automatic fire detection with alarm system
- Public Address - cum Passenger Information System
- Mini pantry consisting of a hot case, microwave oven, coffee maker, bottle cooler, refrigerator and washbasin

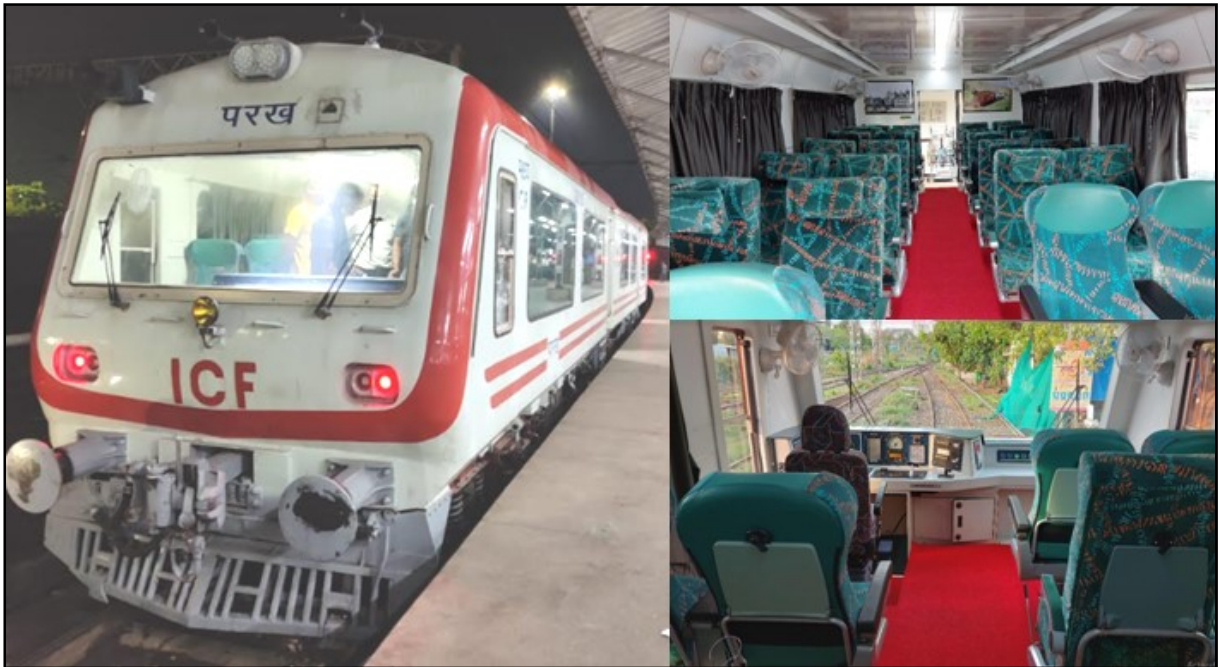
Newly built Self-Propelled Inspection Car (SPIC) no. 200102 CR to be used for emergency inspection and also for reaching railway sites in exigencies for restoration has been successfully commissioned at CSMT coaching depot.

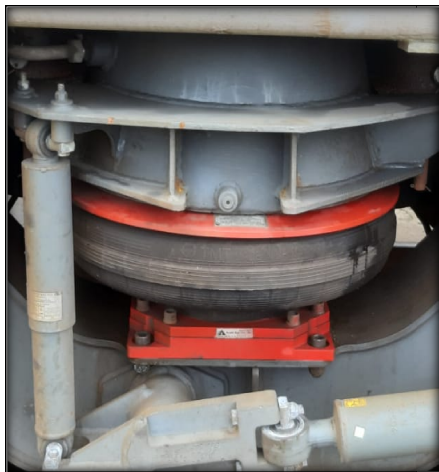
No drain cock is provided in design for Air spring air reservoir in LHB coaches

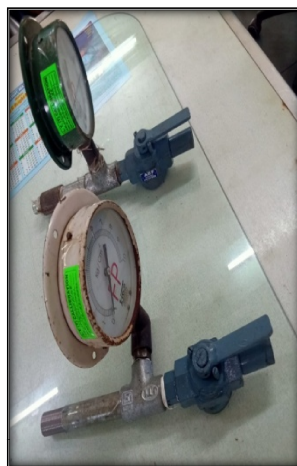
Gadget facilitate checking of FIBA device and draining of AR

With the help of this gadget, FIBA device is checked for malfunction and operation above designed pressure of 1 Kg/Cm². At the same time it facilitates draining of auxiliary reservoir of air spring.

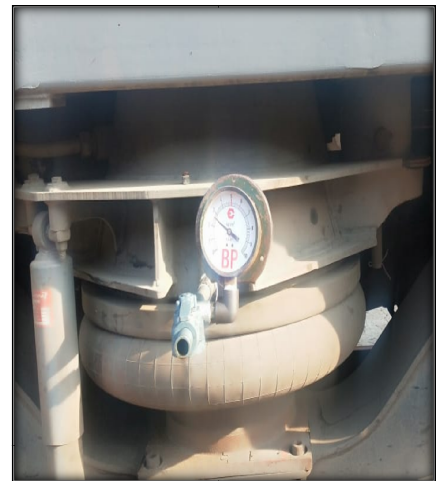
Checking of FIBA device for malfunction with the help of Gadget

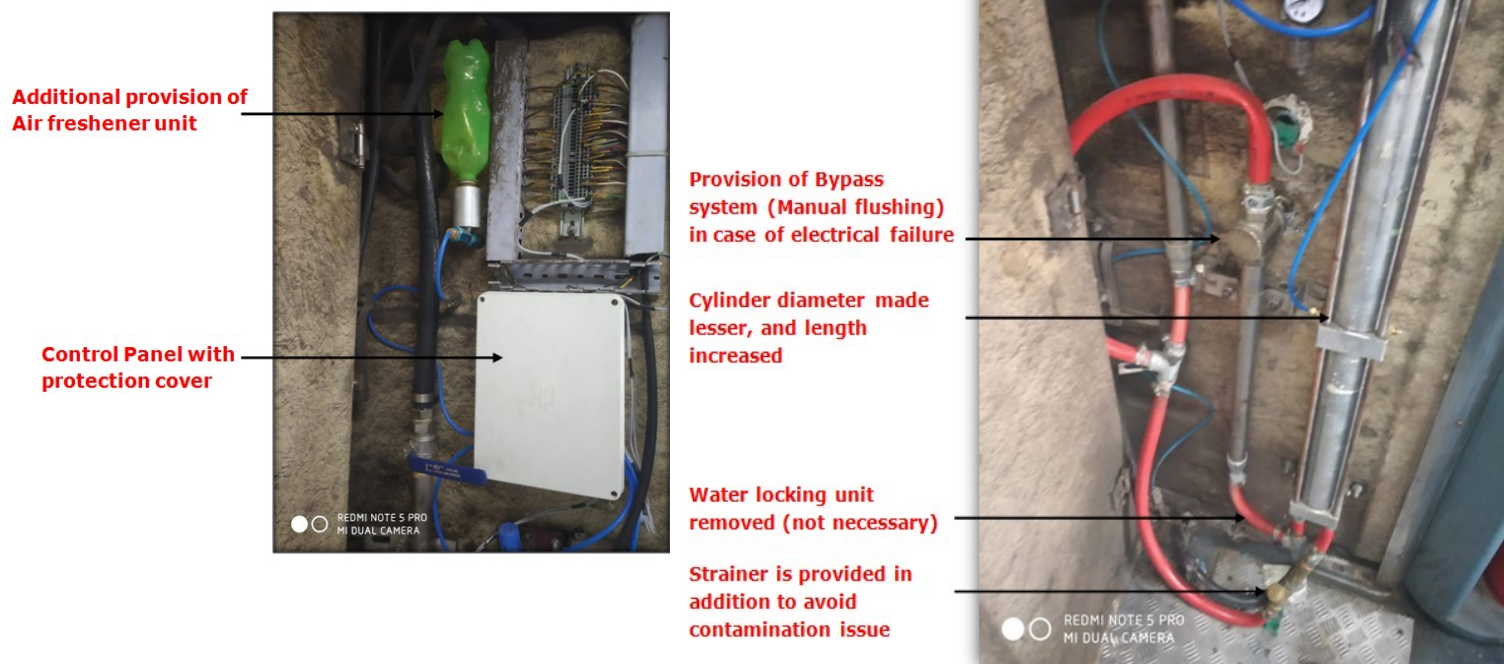
Arrangement of Improved Pressurized Flushing System with provision of air freshener

Learning from the experience and trouble shooting, LTT coaching depot has come up with noble idea of development of improved pressurized flushing system to eliminate above issues for utmost passenger satisfaction. Improved Pressurized Flushing System is installed in coach no CR 15141 LWACCN under trial & monitoring.

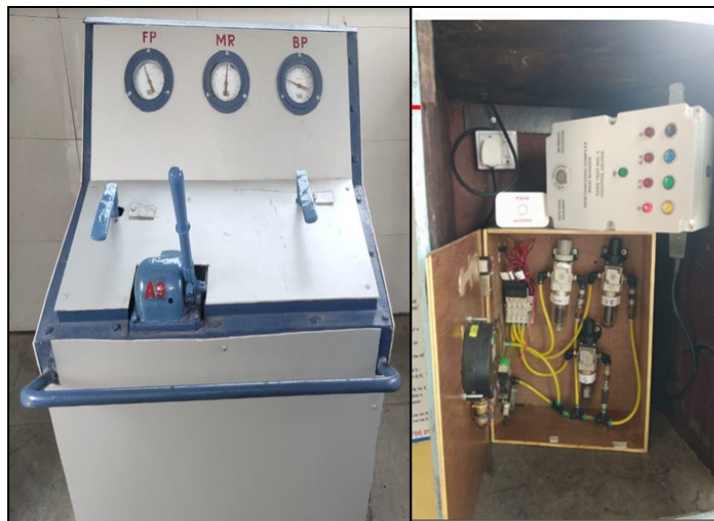
Air Brake system of the coaches is tested by using a 'Rake Test Rig'. Normally, rake test rig is operated by one staff getting advice on walki talki from coworker working on a remote coach. In order to ensure quality of air brake testing by eliminating element of communication gap, Rake test rig of maintenance siding no. 6 at Wadibunder has been converted into App based Remote Controlled Rake Test Rig along with improvement in workstation. **Using mobile application for operation of test rig allows staff to test any particular coach repeatedly and observe components behavior meticulously.**

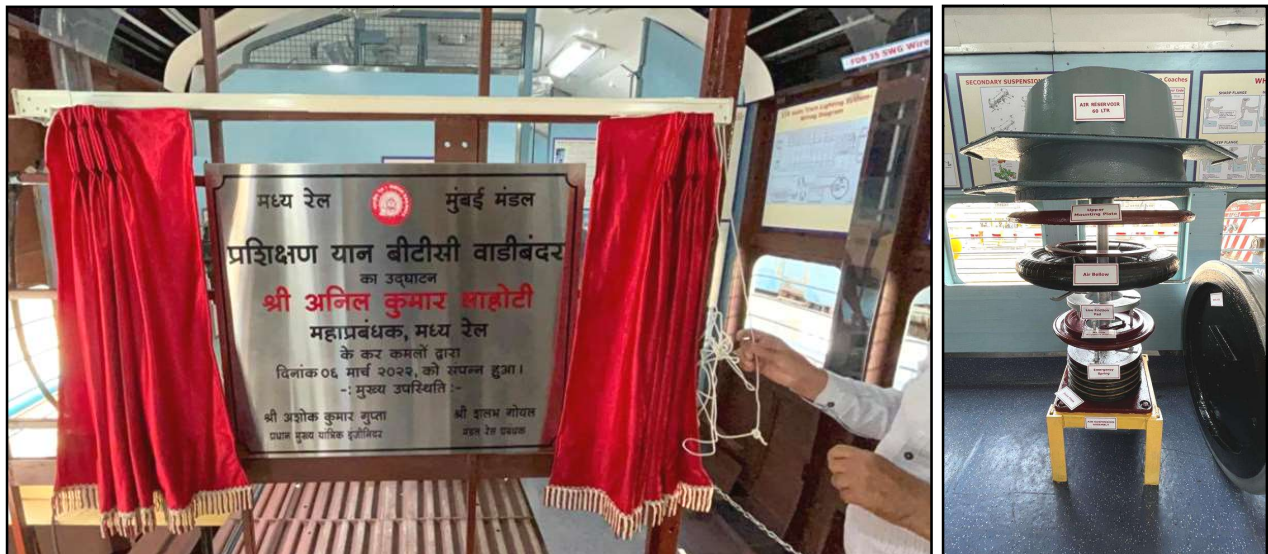
Condemned ICF Coach CN 00296 CR was converted into a Training coach by Basic Training Center, WB. This is an excellent initiative and will help in upgrading the knowledge of staff. The under floor, turn under and all the structural components are visible as cut portions. The staff will have a deeper insight of coach working and also help in appreciation of various defects.

Cut models of components are also displayed. Working model for the Fire suppression system, pressurized flushing system was displayed so that troubleshooting of various defects which arise during maintenance can be taught to the staff.
